IMPORTANT PLEASE FOLLOW PROCEDURE BELOW FOR OPTIMUM ALIGNMENT CHECK

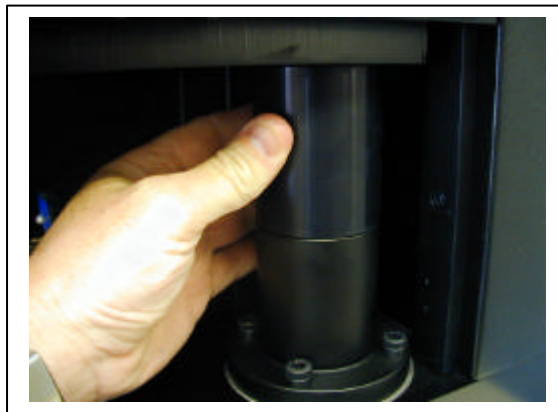
3. With the punch plate fully down, the guide pillar sleeves should be trapped between the bearings and the plate.

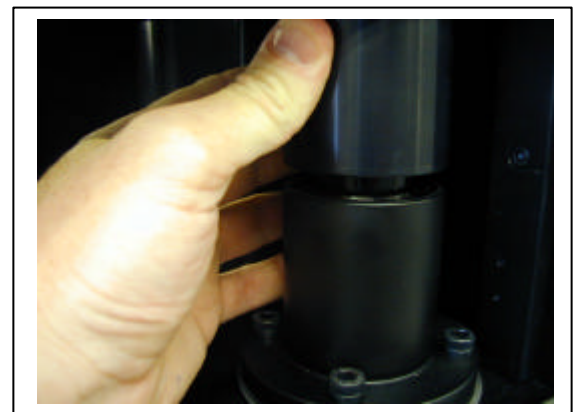
4. If the Punch and Die set is not aligned correctly, the pillar sleeves will move up and down as shown.

5. If a gap can be seen between the punch and die as shown, and the pillar sleeves (in photo 4.) can move freely, realignment will be necessary.
